2023 ODAV Pavement Evaluation Program Seaside Municipal Airport

Seaside, Oregon

December 29, 2023

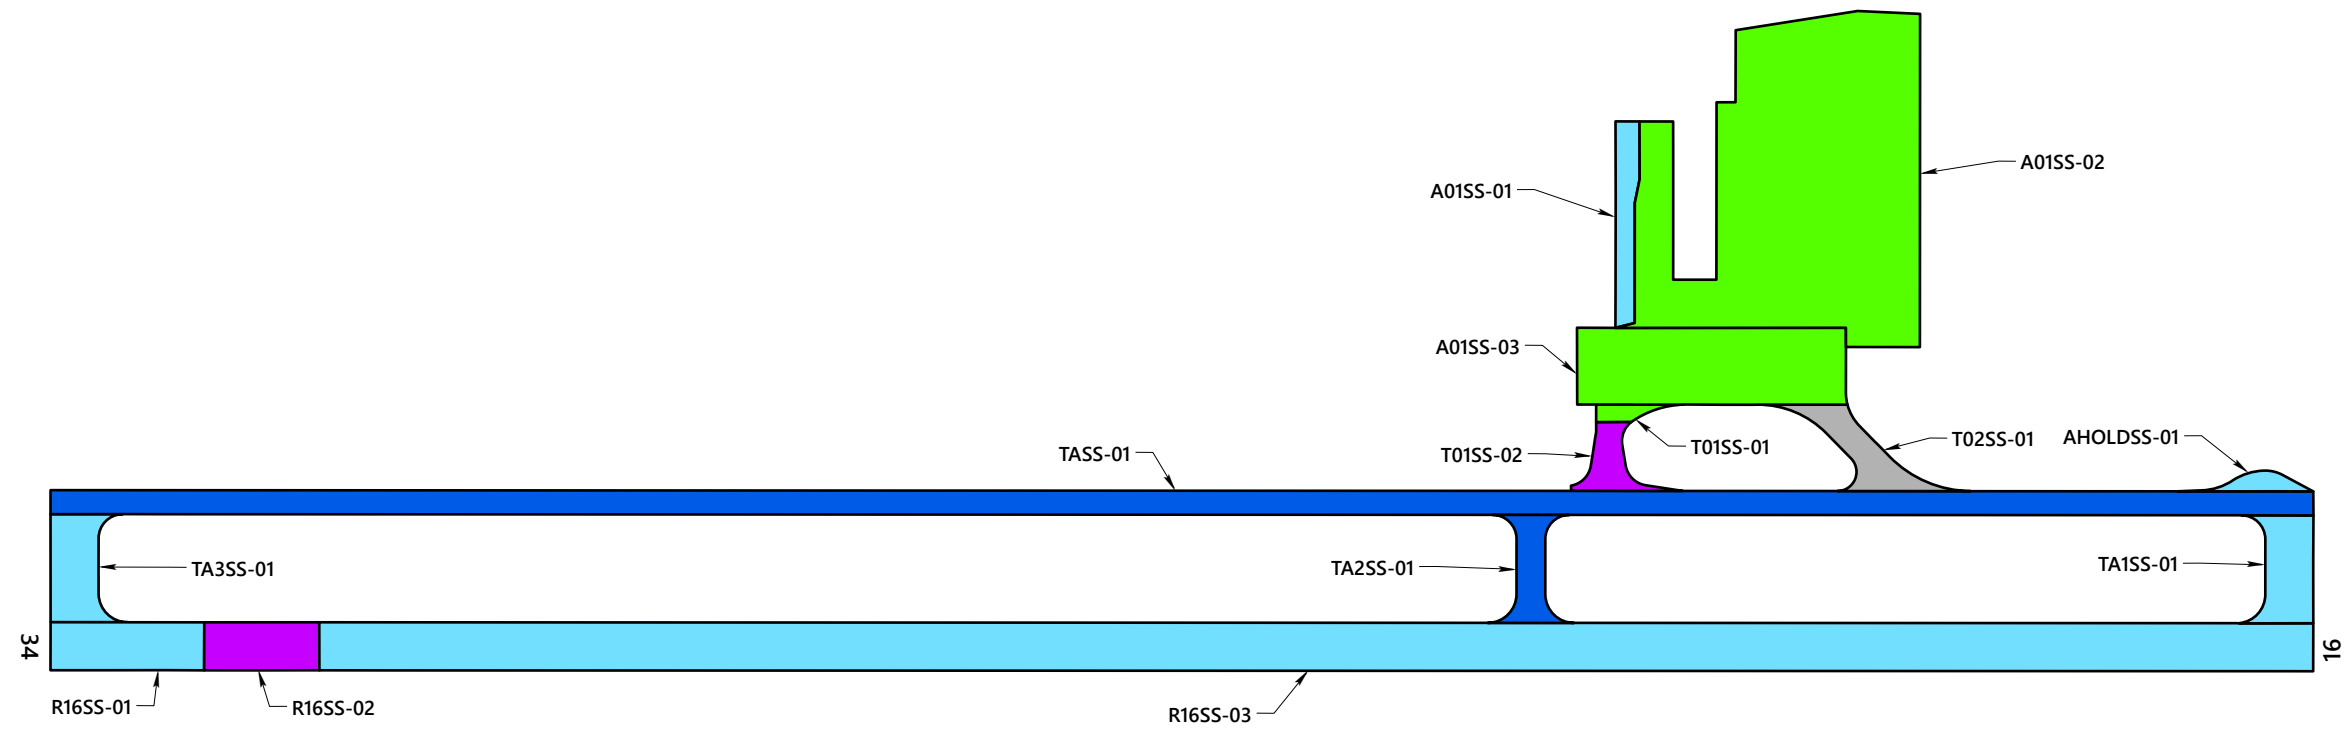
**SEASIDE MUNICIPAL AIRPORT
2023 PCI SURVEY RESULTS**

The area-weighted average PCI for all airport pavements at Seaside Municipal Airport is approximately 63. The section PCIs ranged from a low of 15 to a high of 94. The primary distresses observed during the inspection were weathering, longitudinal and transverse cracking, fatigue (alligator) cracking, depression, and patching on AC-surfaced pavements. Section PCIs following our pavement survey are displayed below spatially on the 2023 PCI Survey Results Seaside Municipal Airport, Figure 3.1.

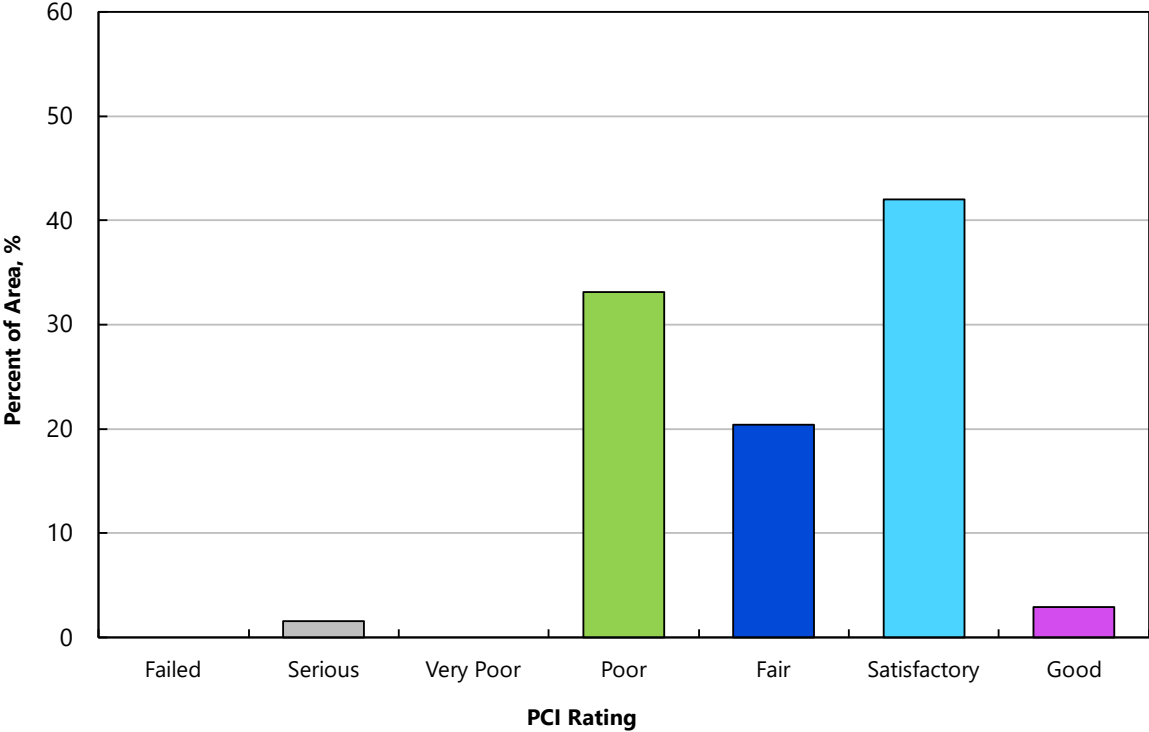
Figure 3.2: SEASIDE MUNICIPAL AIRPORT PAVEMENT CONDITION RATING BY PERCENT OF AREA

The condition distribution of the network by percent of total pavement area is provided on the Seaside Municipal Airport Pavement Condition Rating by Percent of Area, Figure 3.2. A summary of the pavement condition results by branch and section is included in Tables 2B and 3B of Appendix B, respectively. A comparison between the previous inspection and the 2023 inspection is provided in Table 4B in Appendix B. The re-inspection report that includes inspection details for individual sample units is provided in Table 1E in Appendix E.

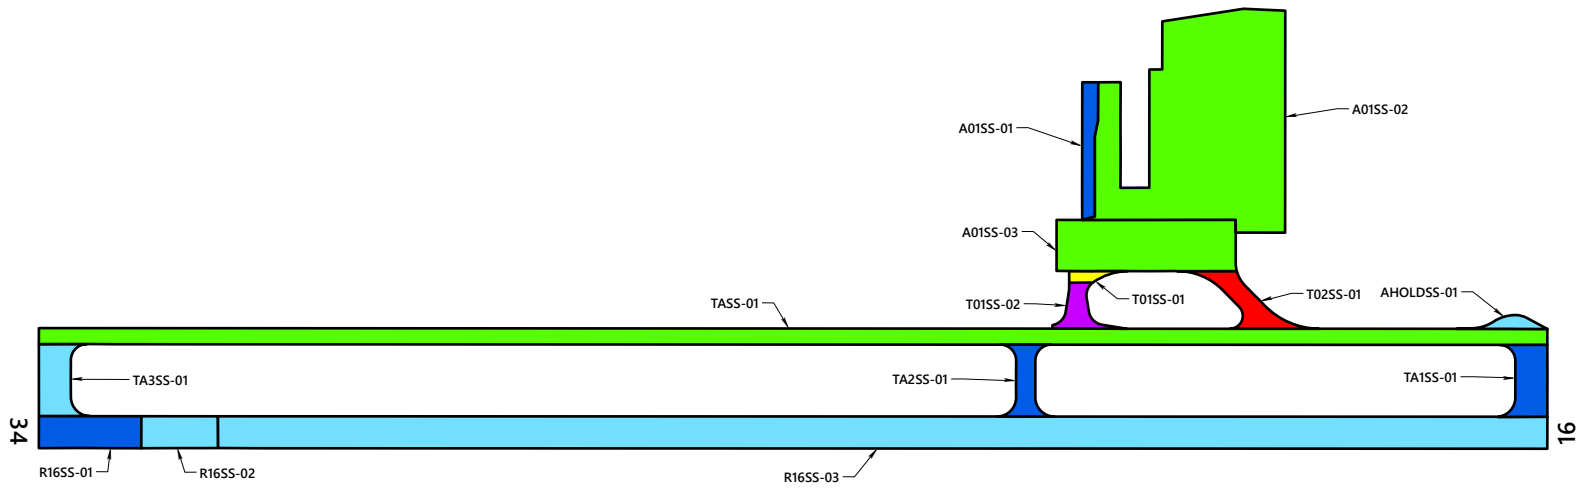
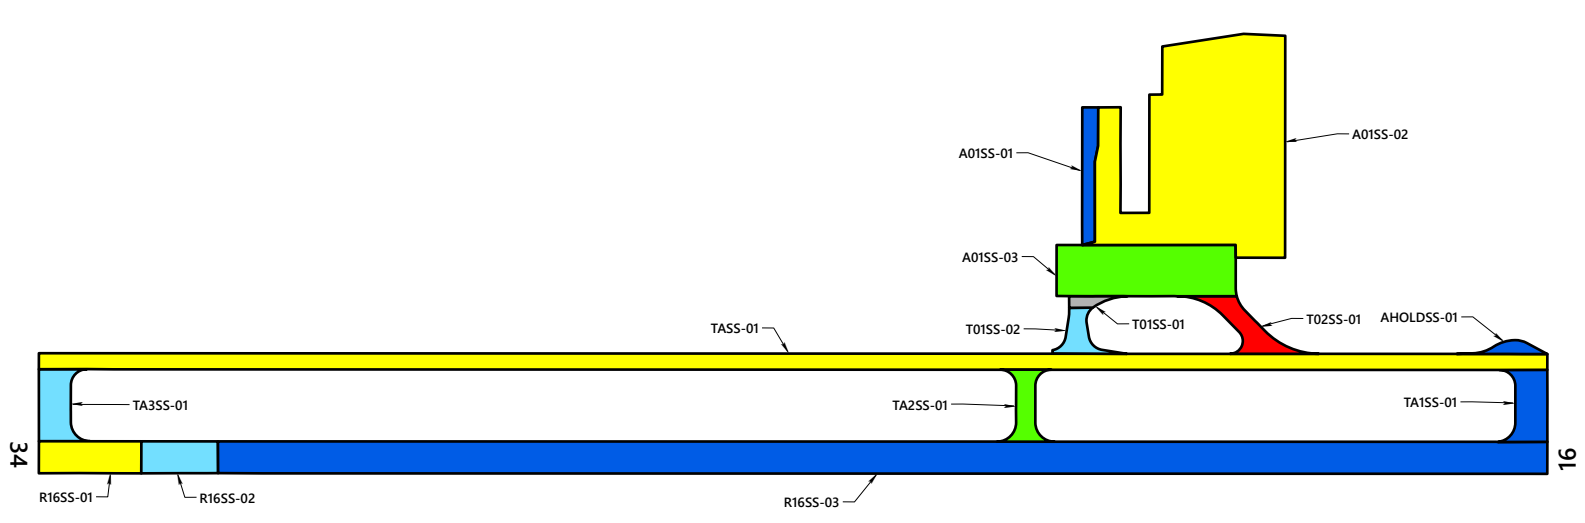
**SEASIDE MUNICIPAL AIRPORT
FUTURE PAVEMENT CONDITION**

Using the condition prediction models discussed above, the projected condition of each pavement section was determined for 5- and 10-year periods. Based on this analysis, we project the PCI to decrease from a current value of 63 to a value of 57 in 2028 and 49 in 2033 if no maintenance or rehabilitation work is performed. The projected pavement condition in 5 years and 10 years for each pavement section at Seaside Municipal Airport is displayed spatially on the Future Pavement Condition Seaside Municipal Airport, Figure 4.1, and listed in Table 1C in Appendix C, along with the past and present PCI values for the pavement network.
